Manhole Inspection Summary

Manhole # S15QQ1002MH

Location Address: **4891 YELLOWWOOD AVE**

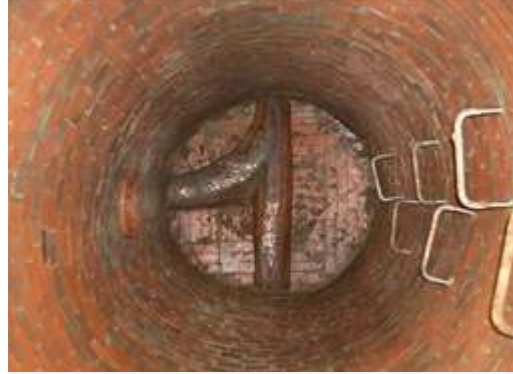
Top View

Barrel infiltration. Bench debris.

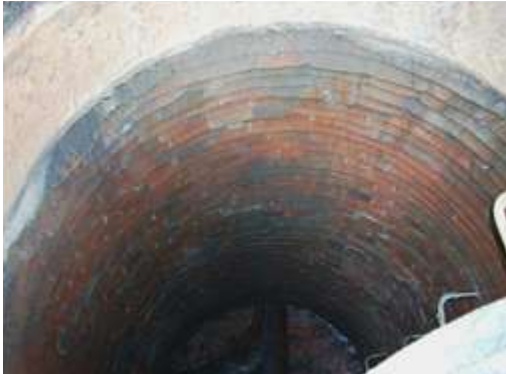
Defect

Frame leaks. Adjustment deterioration and infiltration. Corbel and Barrel infiltration.

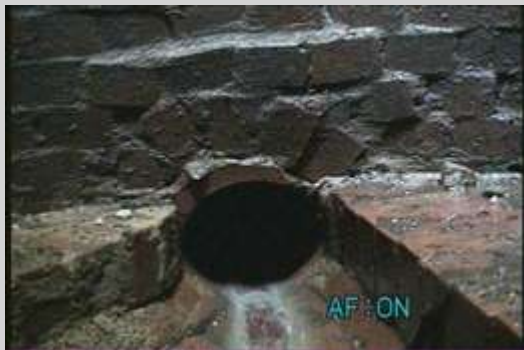
8 in. Circular Gravity Sewer Pipe Out @ 12 O'Clock

Deposits: ☐ None ☐ Mud ☐ Sludge ☐ Debris ☒ Grease

Silt Depth: **0** (in.) Deposits Extent: **Light**
